Illawarra Coast (north) NSW02.04.01

Regional Setting

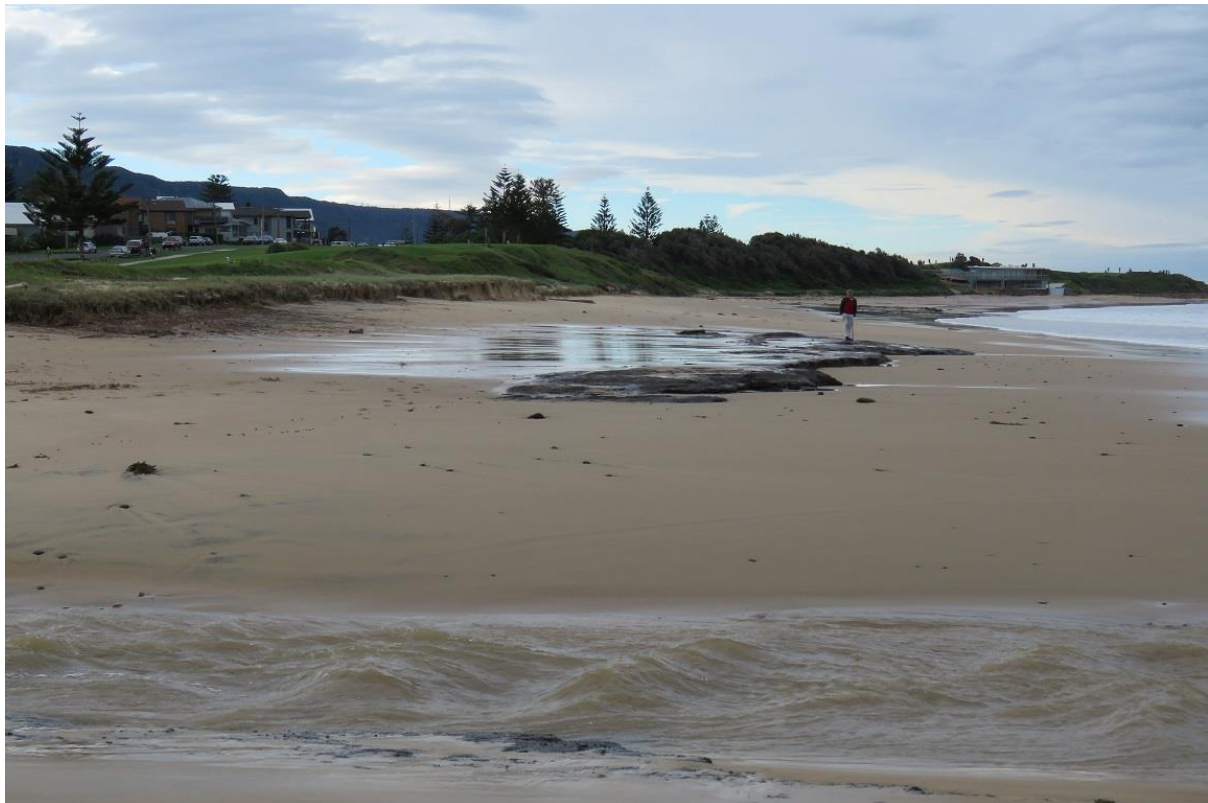
Figure 1 Bulli Beach with muddy peat exposed on the beachface following storm associated with an east coast low in early June 2016. Similar peats were exposed by the 1974 storms and radiocarbon dates of more than 6000 years old (Jones et al., 1979) indicate that this is a receded barrier.

southern end of Thirroul Beach) by erosion (Jankowski et al., 2015). The coastal plain becomes wider, and the beaches backed by broader accumulations of sand. Bulli Beach is a receded barrier that was severely eroded in 1974, exposing mangrove stumps in the beach (Jones et al., 1979). Sand has been accumulating on Woonona beach and other southern Illawarra beaches, resulting in local beach reshaping around surf clubs (Beardsmore et al., 2014). Bellambi Point forms a prominent headland at the southern end of this secondary compartment; erosion on Bellambi Beach is reported with medium confidence by Chapman et al. (1982).
