## Ninety Mile - Gippsland Lakes VIC02.02.02

### Regional Setting

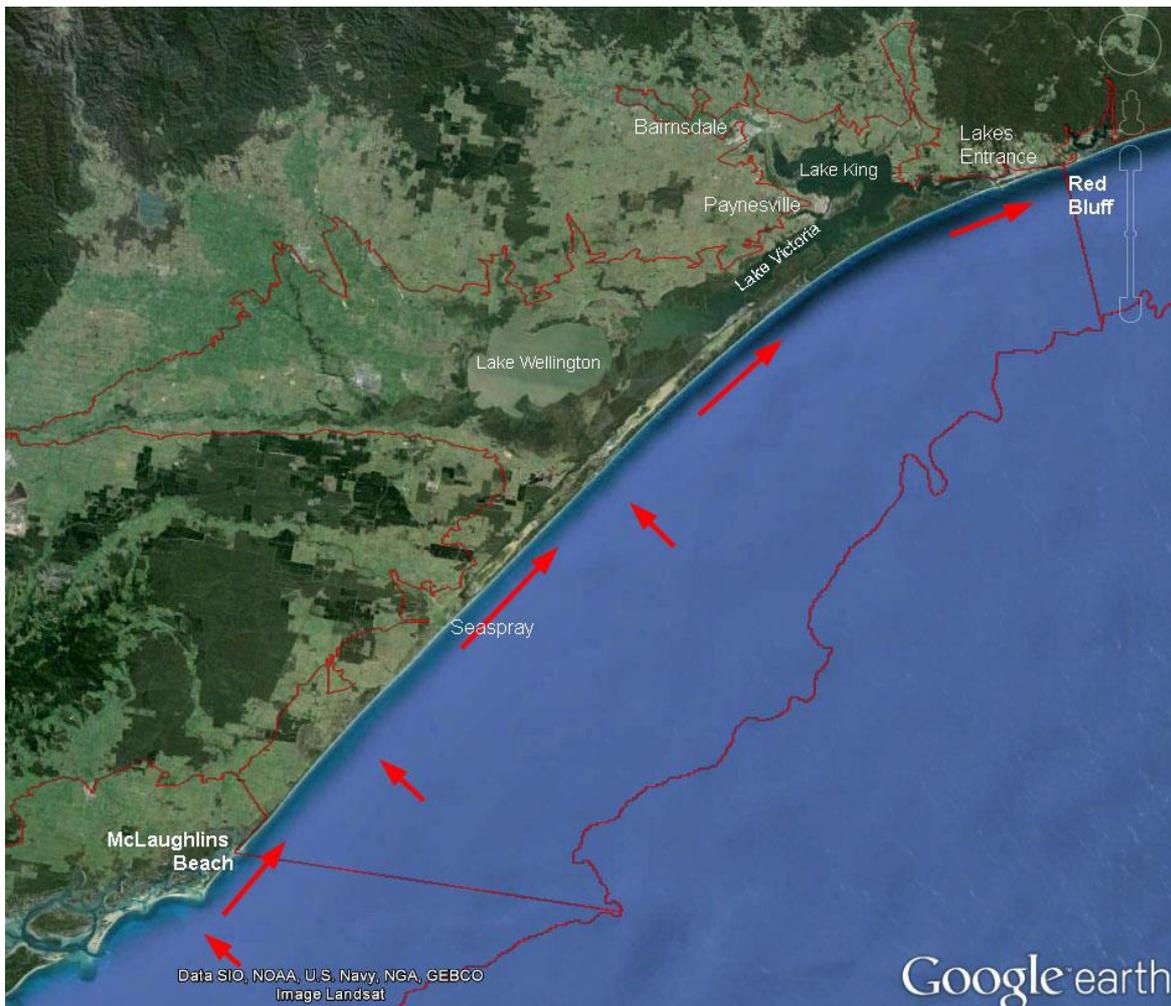
**Figure 1:** Compartment VIC02.02.02 Ninety Mile Beach - Gippsland Lakes. Red arrows represent inferred dominant sediment transport patterns. In future with rising seas reaching a point where storm wave wash-over becomes more frequent, barrier translation or 'roll-over' may result in significant amounts of sand also being transported landwards, partly by wave over-wash and partly by wind action.

Sediment transport modelling (Harris & Heap 2014) suggests shorewards transport of sand from Bass Strait is likely continuing today between Corner Inlet and Seaspray. Evidently, this is occurring at a rate insufficient to prevent a degree of shoreline recession and alongshore sand loss, as observed in recent decades along much of Ninety Mile Beach (see below). The northwards spread of Holocene barriers, from a single barrier in the southwest to a double barrier in the northeast towards Lakes Entrance, reflects long-term accumulation of sand from the southwest towards the northeast through north-eastwards littoral drift; this remains the dominant drift direction today (see Fig. 1.10 in Short and Woodroffe, 2009).

level rise. The north-eastern portion of the beach is likely to be a late responder to sea-level rise, owing to its gaining sand budget. The initial impacts of sea-level rise are expected to be recession of the outer barrier front, with loss of sand offshore and alongshore, accompanied by beach accretion at the northeast end. However, with continuing sea-level rise, there is expected to be increased breaching and over-wash of the outer barrier, leading to a landwards translation of the barrier (Womersley, Rosengren & Mawer 2013). This may result in the north-east end of the beach then receiving less sand and beginning to recede.

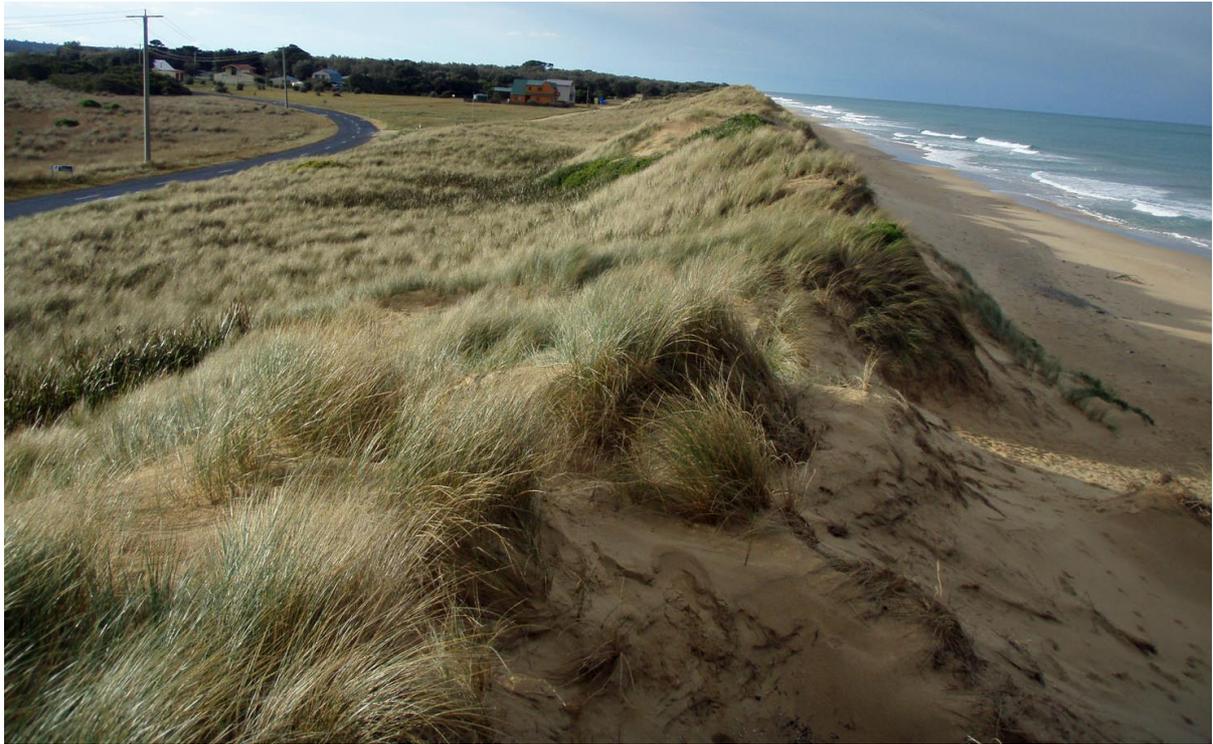
**Figure 2:** View north-eastwards along Ninety Mile Beach and the outer dune barrier at the Honeysuckles (near Seaspray). This is one of the narrowest points in the outer barrier. Photo by C. Sharples (2010).
