Key findings:

East Coast Lows and the Newcastle-Central Coast *Pasha Bulker* storm

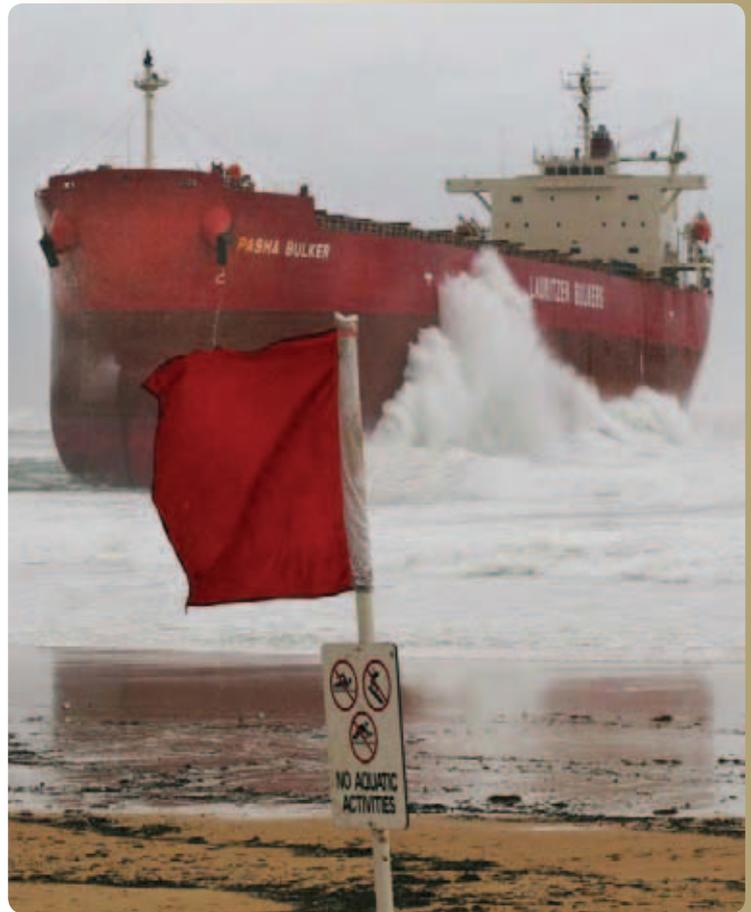
Pasha Bulker grounded on Nobby's Beach. Image: PJ Rosenberger

Of these five, the first (June 8-9) was the most serious (in terms of impact) and resulted in widespread flooding and wind damage, coastal erosion, the grounding of the *Pasha Bulker* (a 40,000 tonne bulk carrier ship) on Nobbys Beach, Newcastle and the loss of nine lives.
