Port Davey - Bathurst Harbour TAS02.02.02

Regional Setting

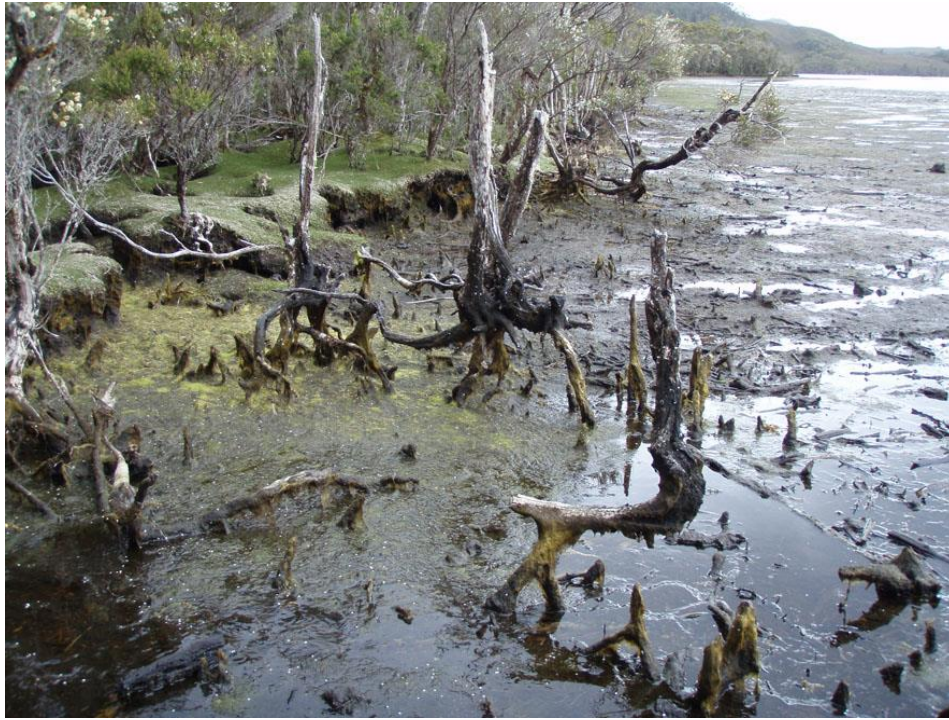
Figure 2: Active recession of ‘marsupial lawn’ peat shores (a type of saltmarsh) is widespread in sheltered inlets around Bathurst Harbour and Bathurst Channel. This example from Horseshoe Inlet shows *Melaleuca* skeletons – which grow landwards of the marsupial lawn zone – isolated by several metres of recent shoreline recession. Photo by C. Sharples (2010).

However, small swell-sheltered, sandy pocket beaches deeper within the ria are commonly showing active erosion scarps, with major tree roots being undermined and no signs of recovery (examples include Bond Bay and Balmoral Beach). Unusual saltmarsh-like, soft sandy-peat shores known as 'marsupial lawn' are also widespread in sheltered inlets, where they accumulate as the growth of intertidal herbs traps sand and organic debris. These shores are capable of natural recovery after erosion but are nearly everywhere showing active erosion scarps receding through backing *melaleuca* vegetation, with only sub-ordinate areas of recovering shores. There is no sand input to these shores (from river or shelf sources).

The soft, swell-sheltered, sandy and marsupial lawn shores are being eroded by local wind waves, and their apparently progressive recession without recovery (which the marsupial lawn shores should be capable of) is likely to be an early response to sea-level rise, and can be expected to continue. In some areas, shoreline recession will be halted by nearby rising bedrock slopes. In other areas, low, soft sediment, backshore infills may allow considerable shoreline recession.
